# **A Summary of Crashworthiness Information of Small Airplanes**

**FEBRUARY 1973**

FAA Technical  
Report No. FS-70-592-120A

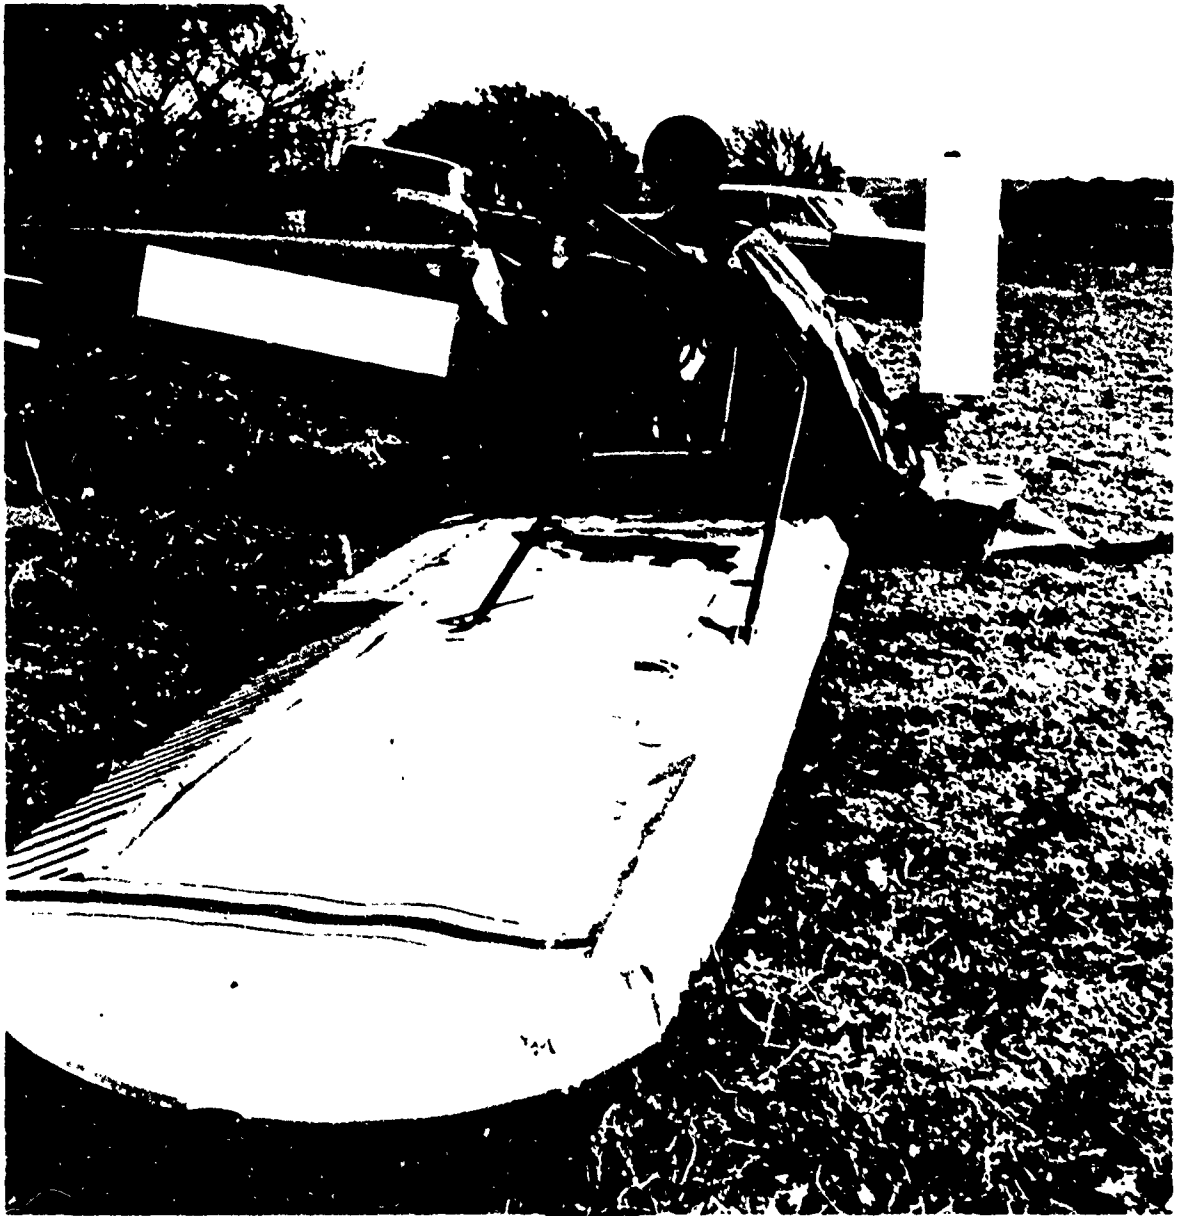
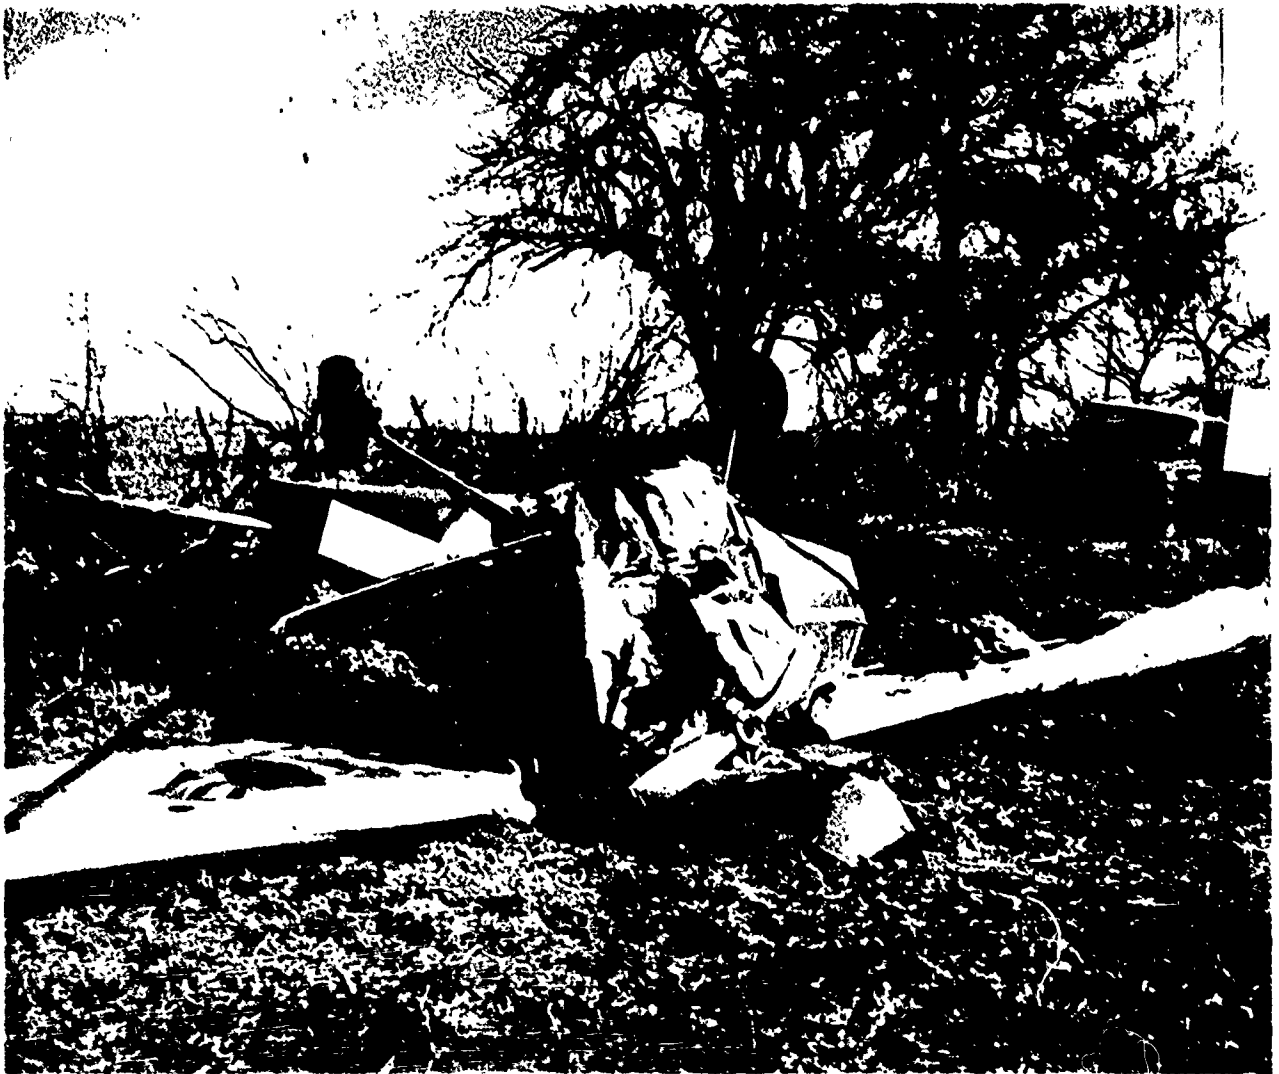
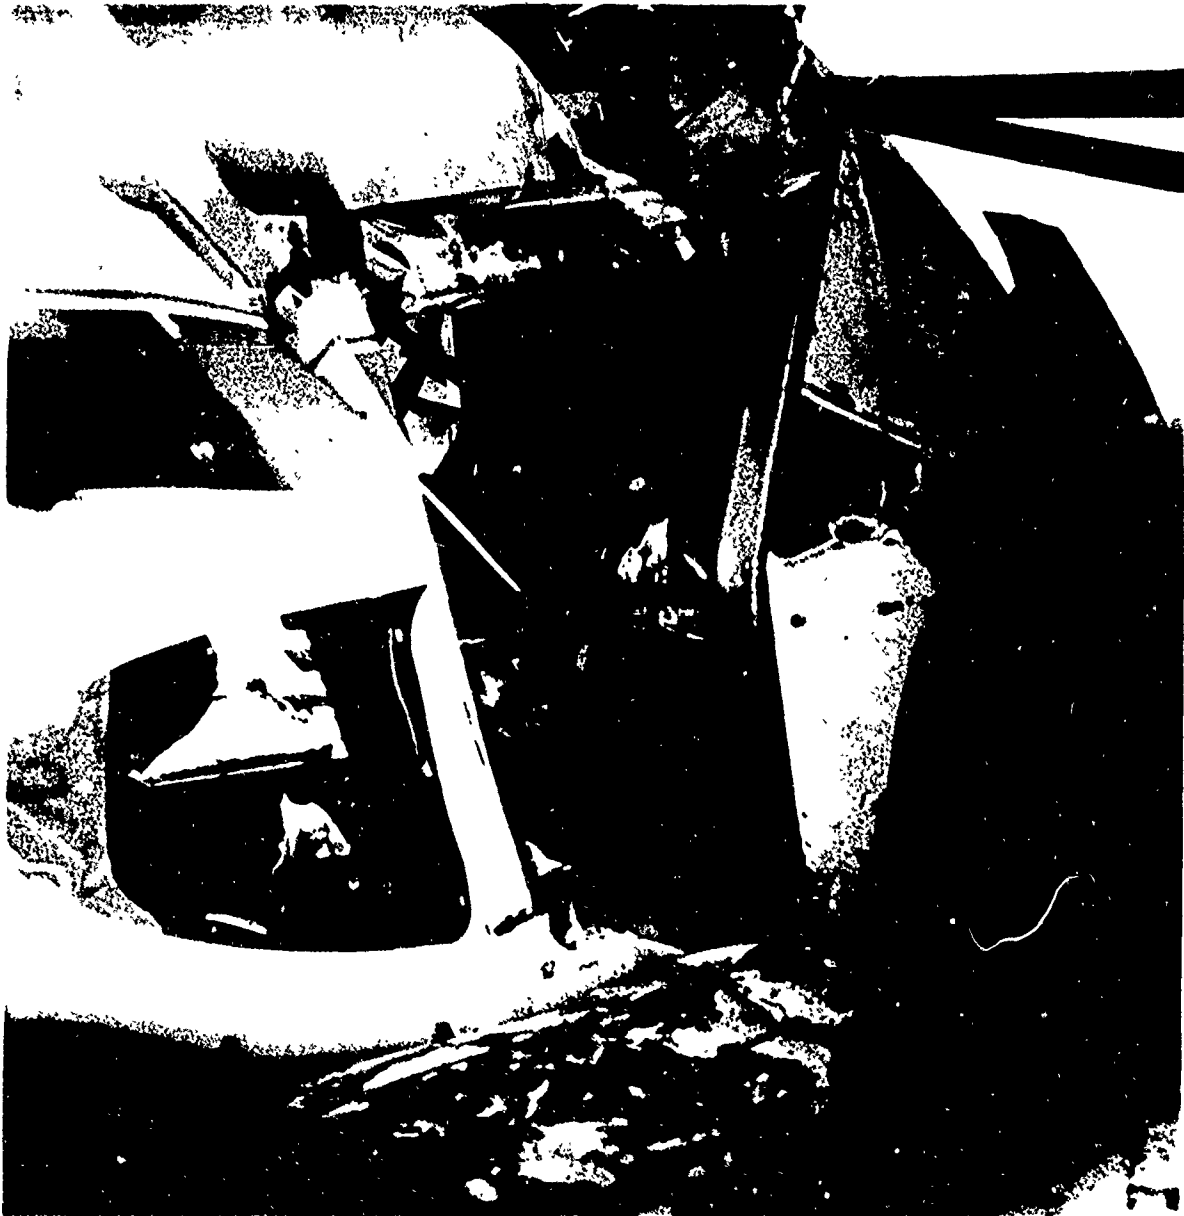
Figure 2-1(a).  
Typical Severe Accident, Fixed, High-wing, Light Aircraft

Of the two accidents shown in Figures 2-1 and 2-2, the latter appears to have been the more severe. The damage shown in Figure 2-2 may have been caused by a series of impacts, rather than by a single impact like that of Figure 2-1. Although both airframes provided a basic crash cage, the low-wing design provided protection to the floor area. However, the high-wing design provided substantial protection in the roll-over position. Also, the landing gear location, remote from the cabin, prevented the landing gear's protuberance into the cabin floor.

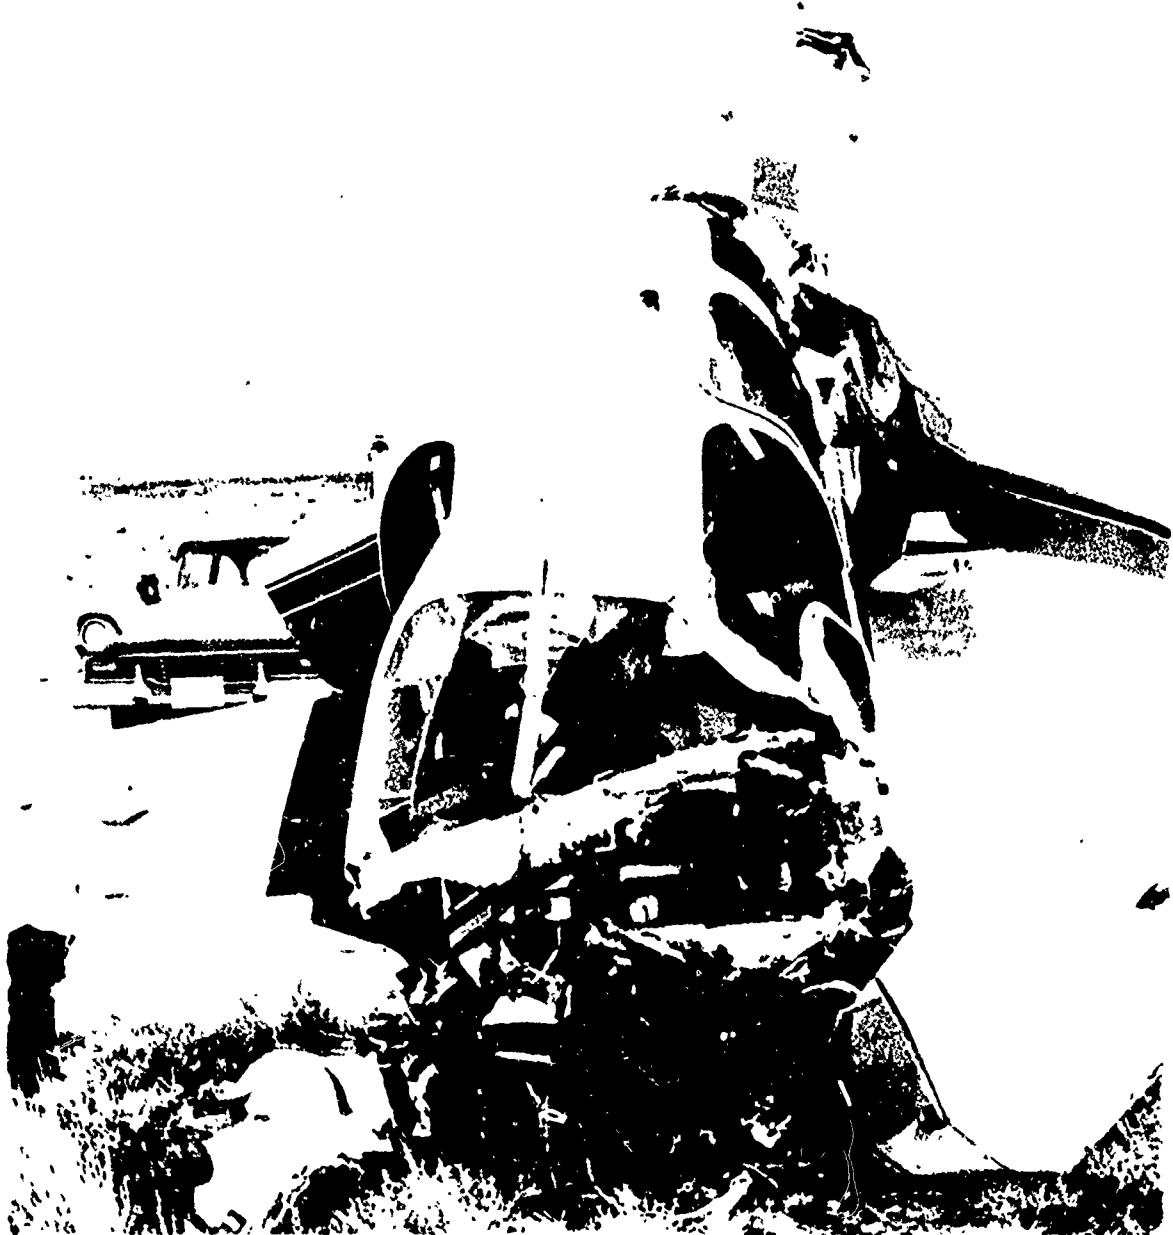
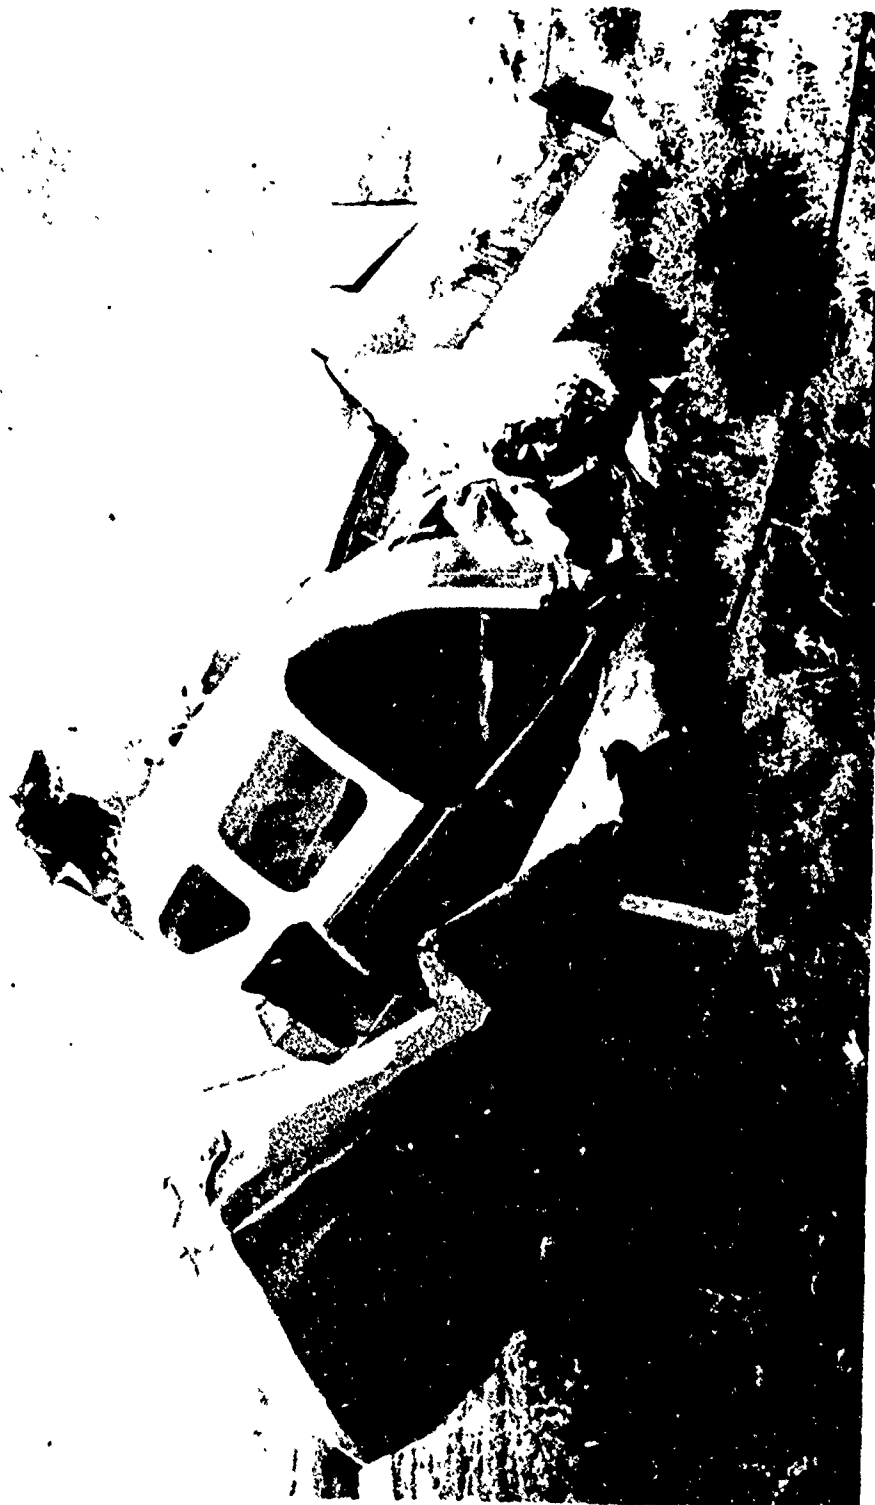
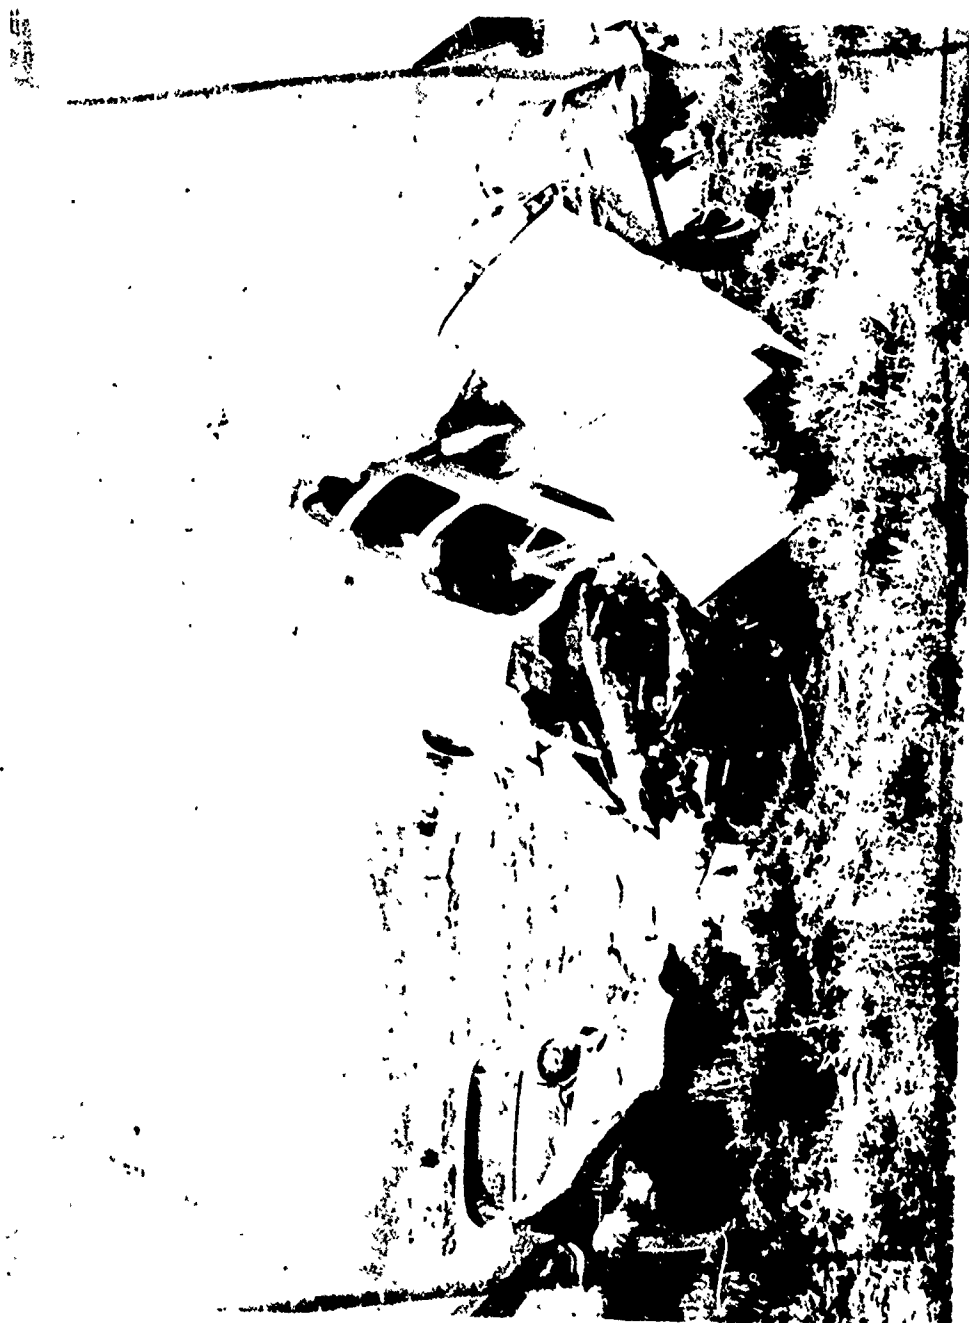
Figure 2-2(a)  
Typical Severe Accident Fixed, Low-wing, Light Aircraft

The accident shown in Figure 2-2 involved a low-wing, retractable landing gear, light airplane. The circumstances leading to this accident are not known, but the consequences are apparent. Wings, aft fuselage, and

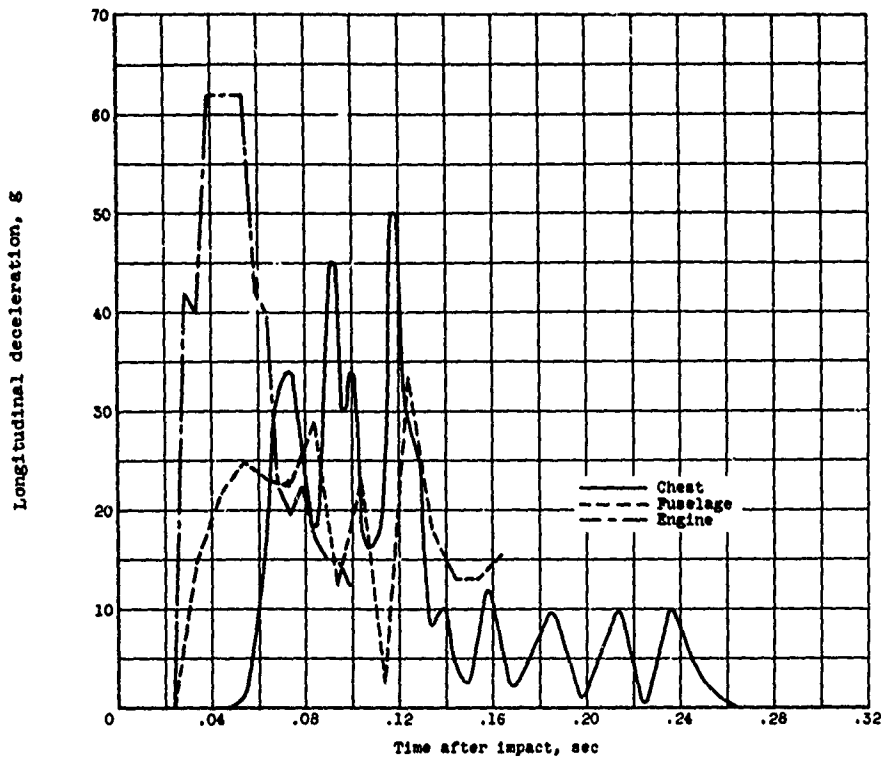
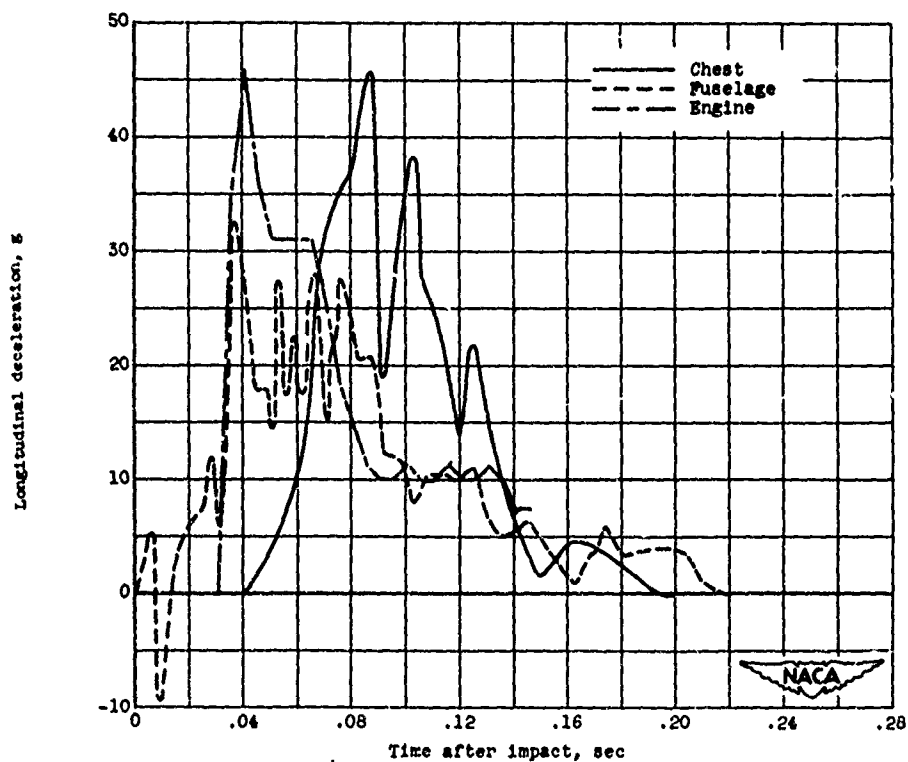
(a) Impact speed, 60 mph.

Figure 2-5. Longitudinal deceleration of engine, fuselage floor at rear seat, and chest and head of rear dummy.

(b) Impact speed, 47 mph.

The structure that collapsed in the Piper Cub tests was that forward of the rear seat. The deceleration traces illustrate the effects of the strength of the forestructure. There were differences of about 30g, 12g, and 5g, between the engine compartment and the rear seat location. This points out a significant effect of the forestructure under the tested conditions.

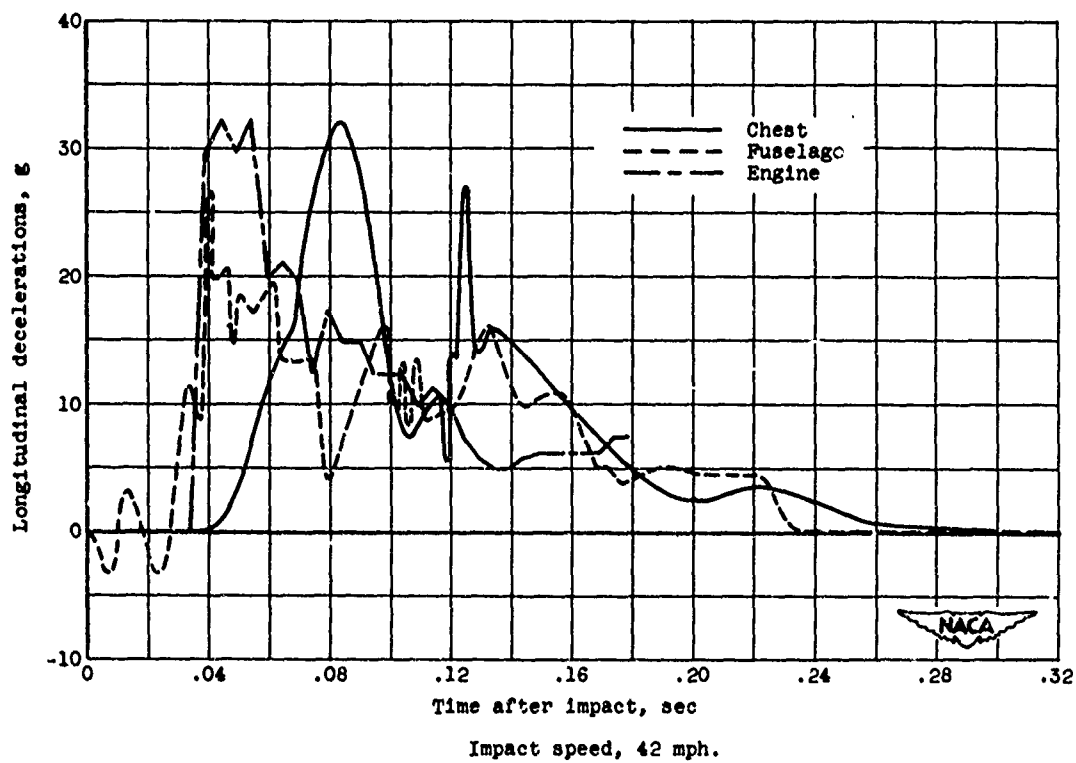
Figure 2-7. Longitudinal deceleration of engine, fuselage floor at rear seat, and chest and head of rear dummy.

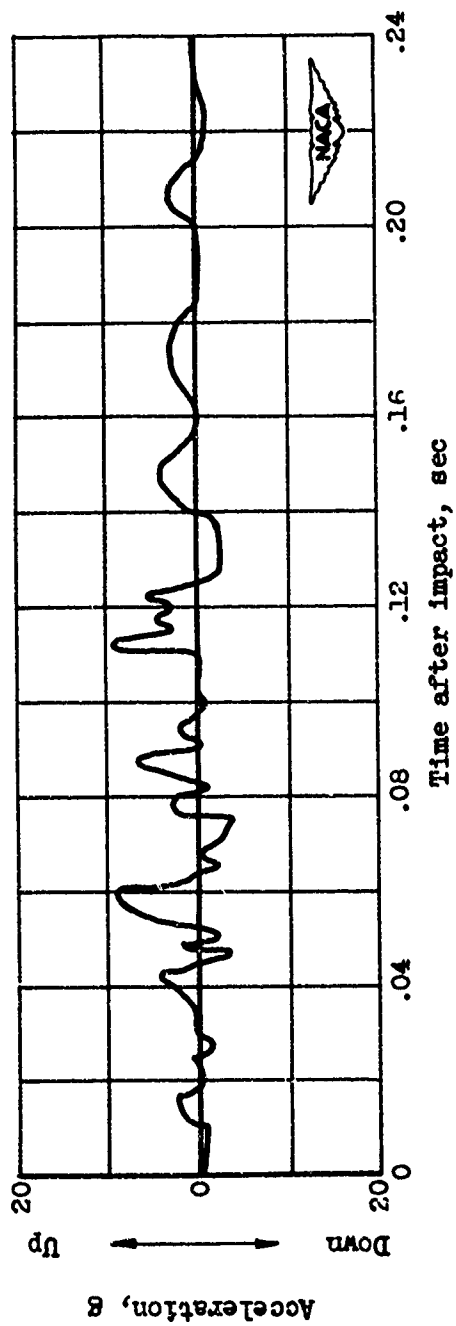
Figure 2-9. Vertical acceleration of fuselage floor at rear seat in 42-pmh crash.

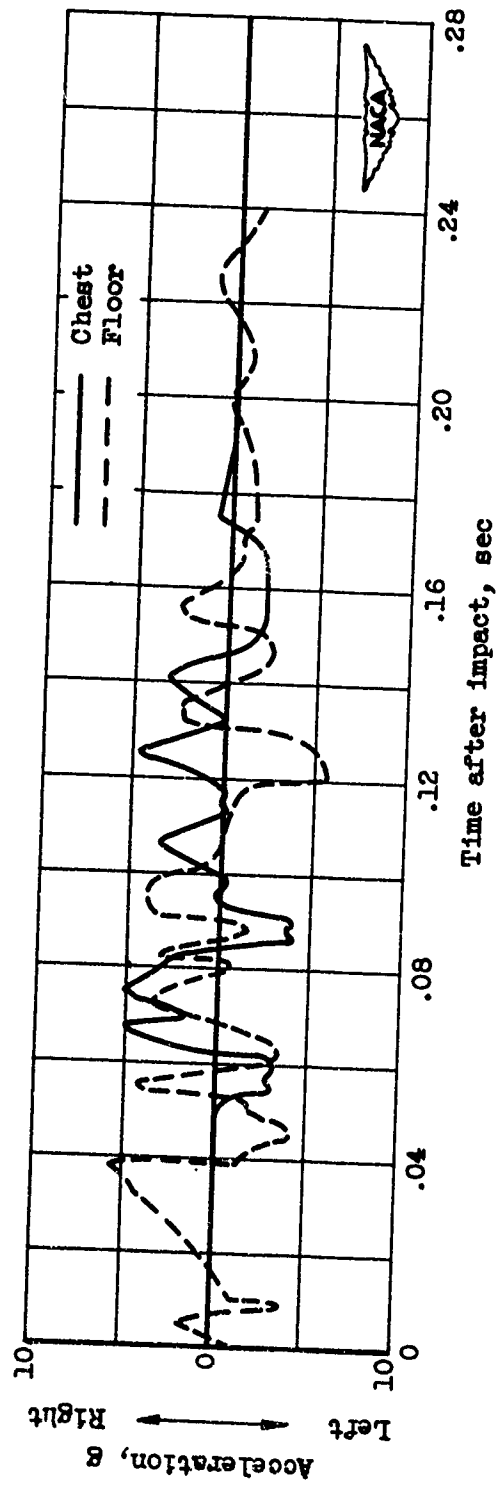
Figure 2-10. Time history of lateral acceleration as measured on chest of rear dummy and fuselage floor at rear seat in 42 mph crash.

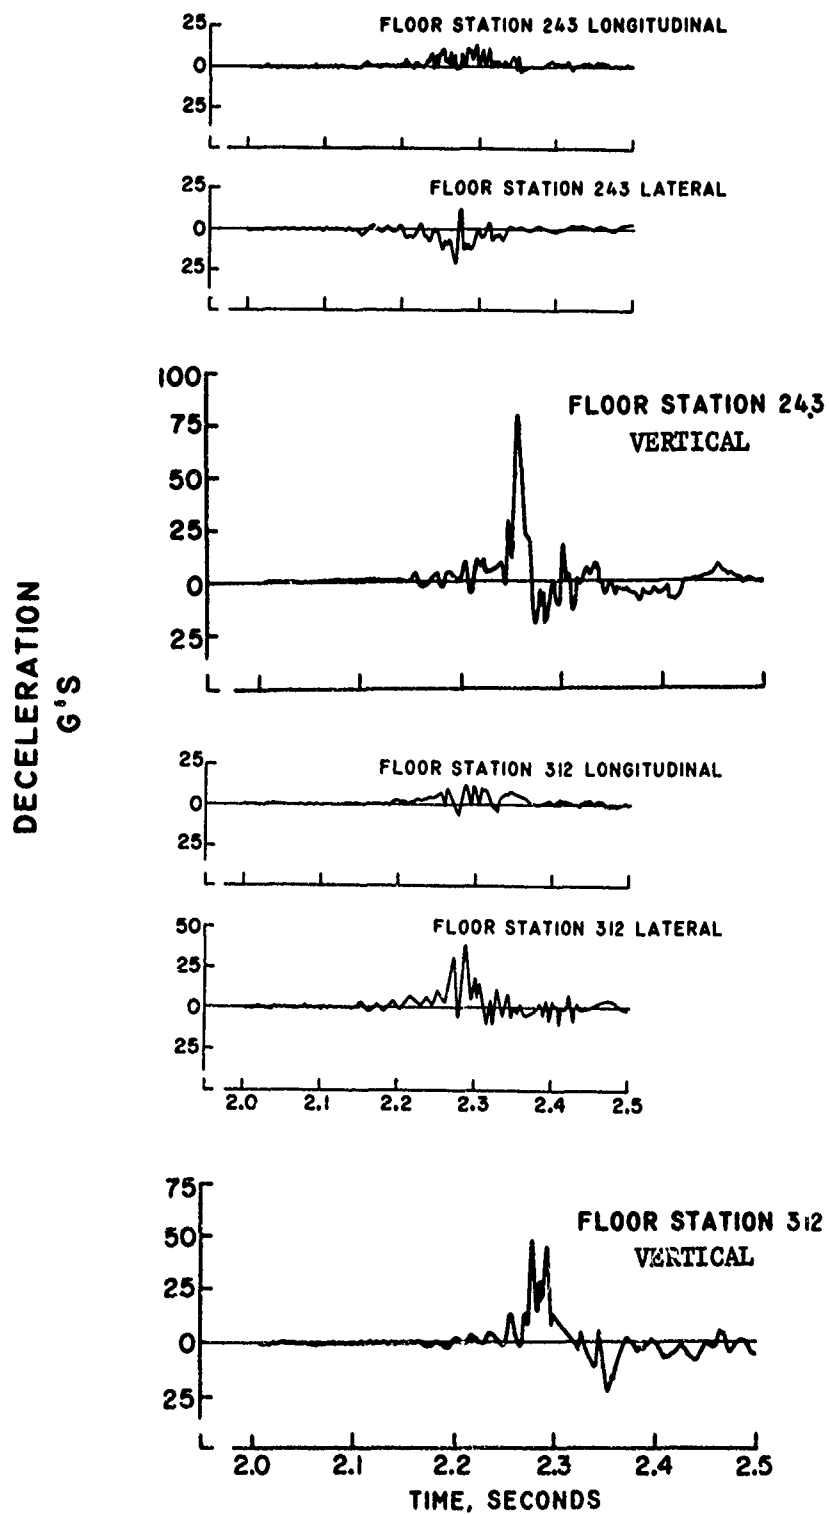
Figure 2-12  
Longitudinal, Lateral and Vertical deceleration resulting  
from second impact, 12° crash of R-5-0 Loadstar airplane.

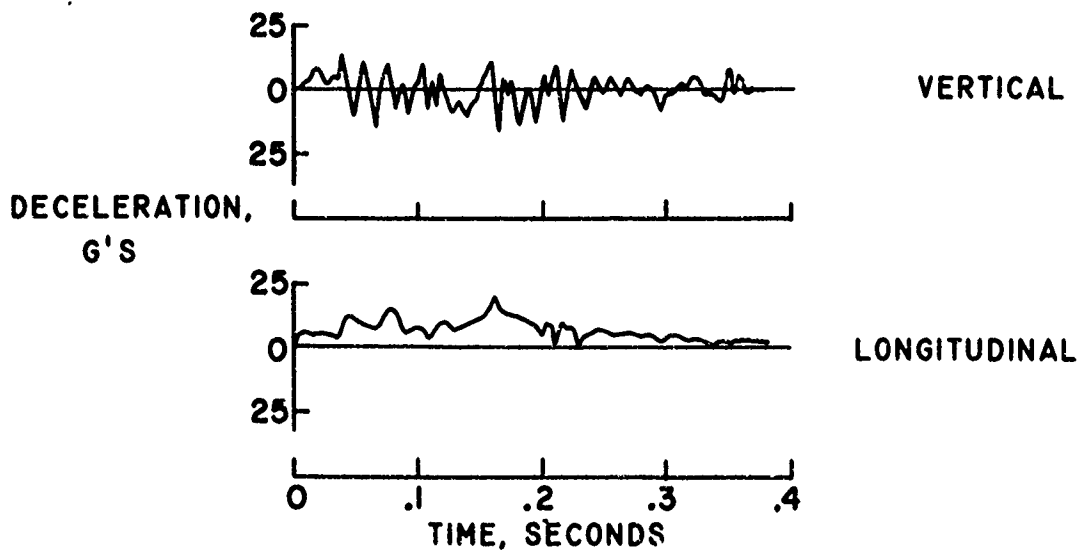
Figure 2-15. Longitudinal and vertical decelerations resulting from first impact in 16° crash of R-5-0 Lodestar transport airplane.

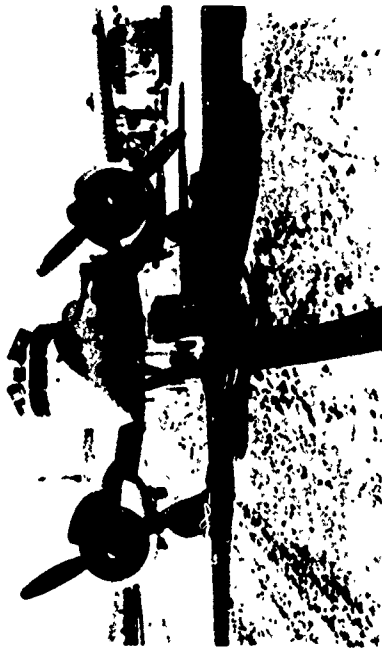
Figure 2-17 Typical Front View of Test Aircraft, Precrash.

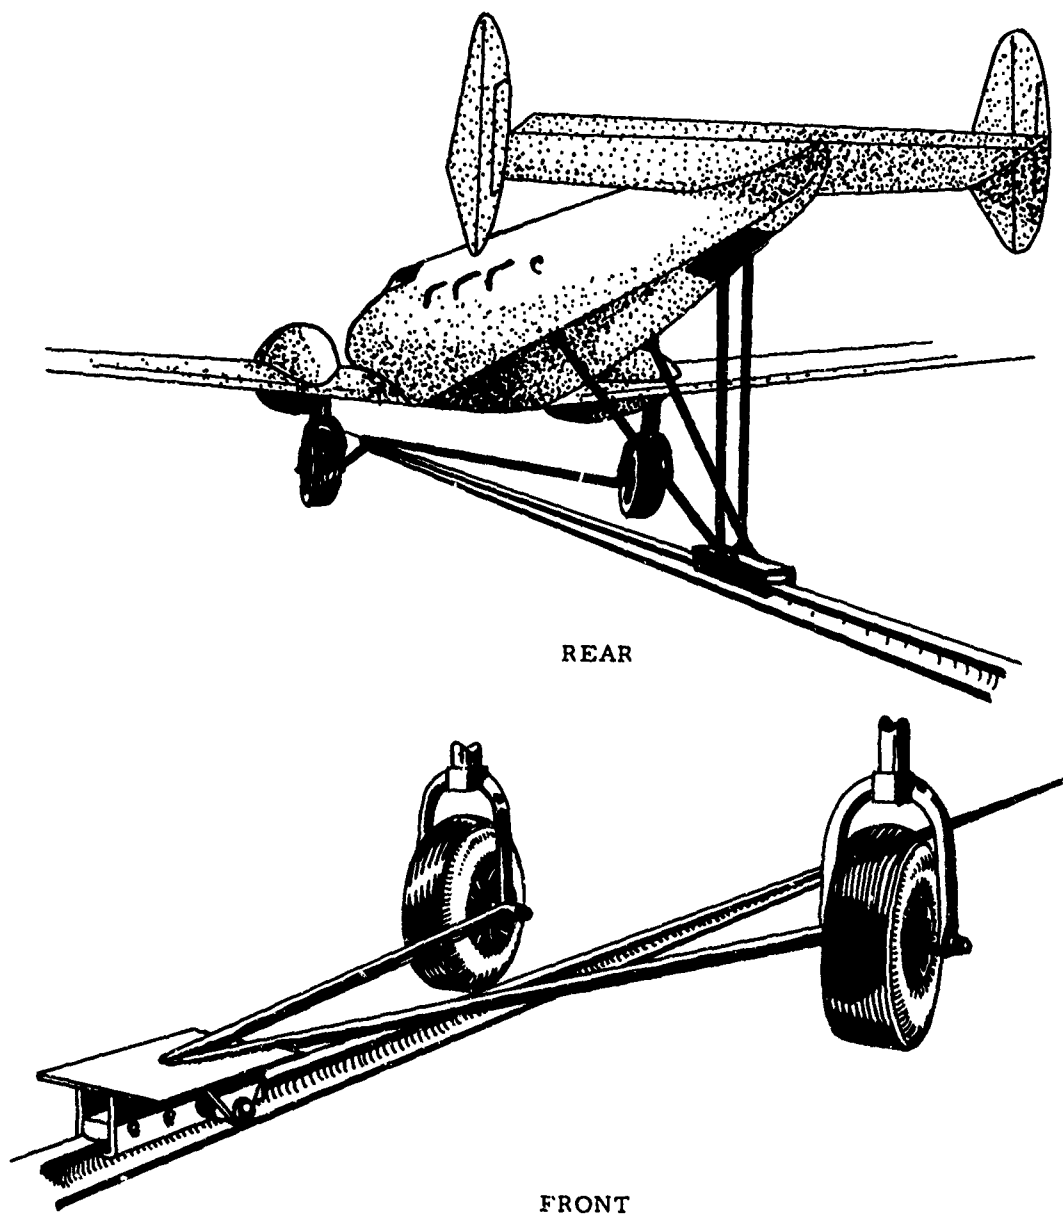
Figure 2-19. Aircraft Guidance System - Front and Rear Views.

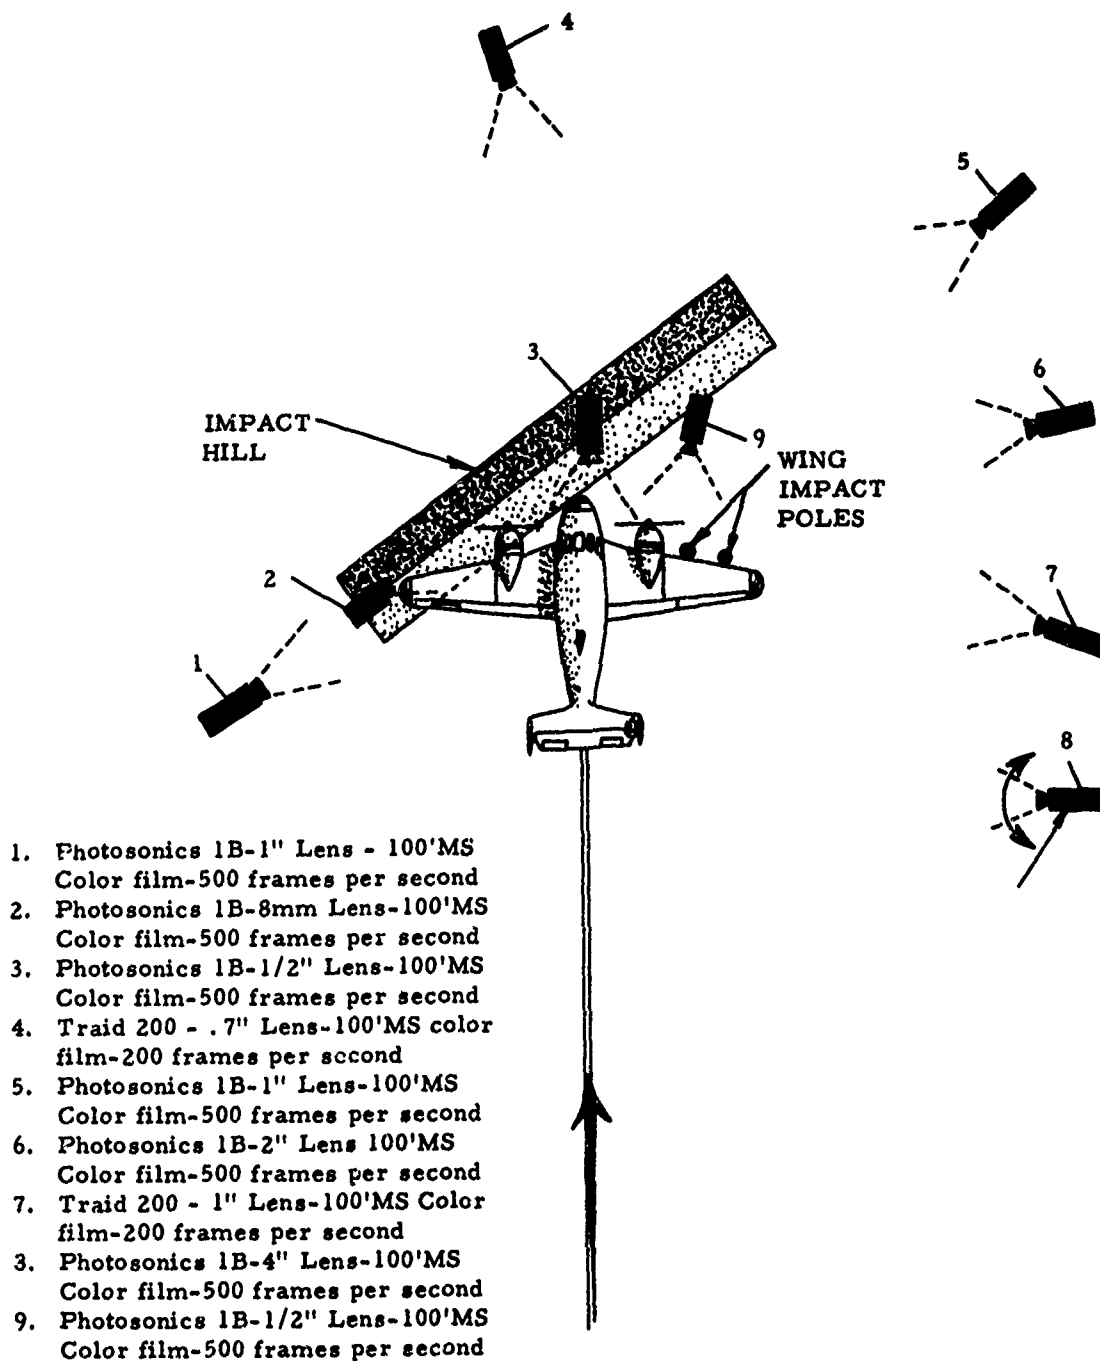
Figure 2-20. Ground Camera Locations

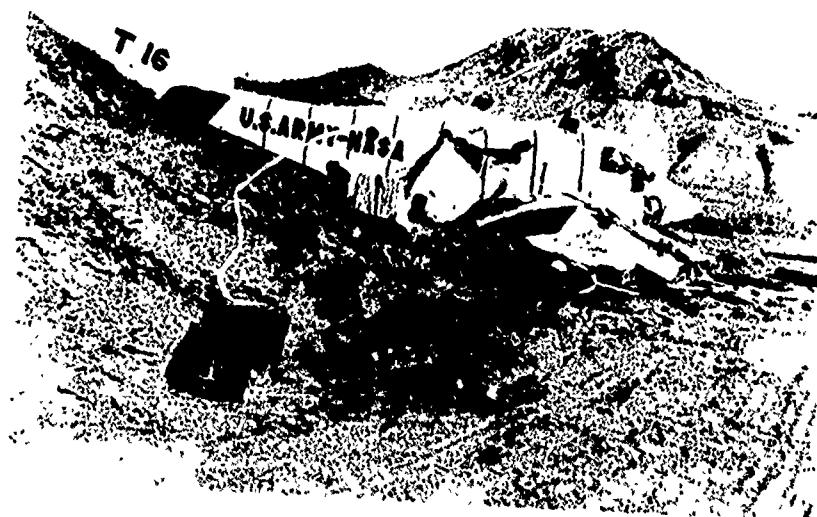
Figure 2-21. Right-Side View of T-16 Vehicle, Postcrash.

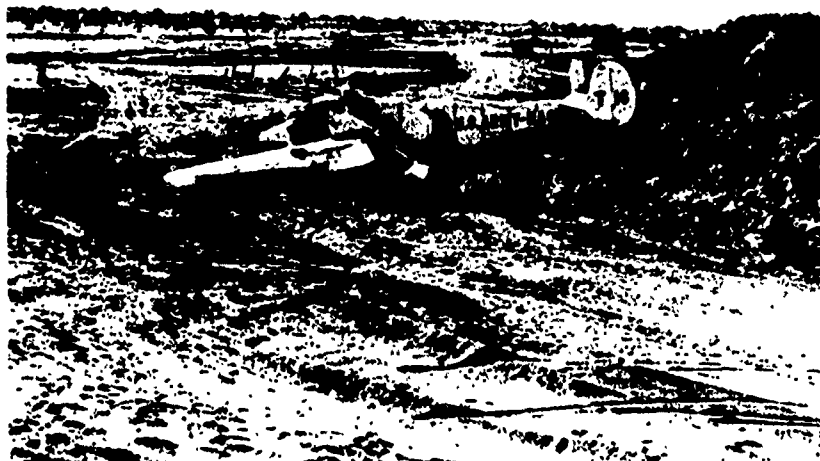
Figure 2-23. Left-Side View of T-16 Vehicle, Postcrash.

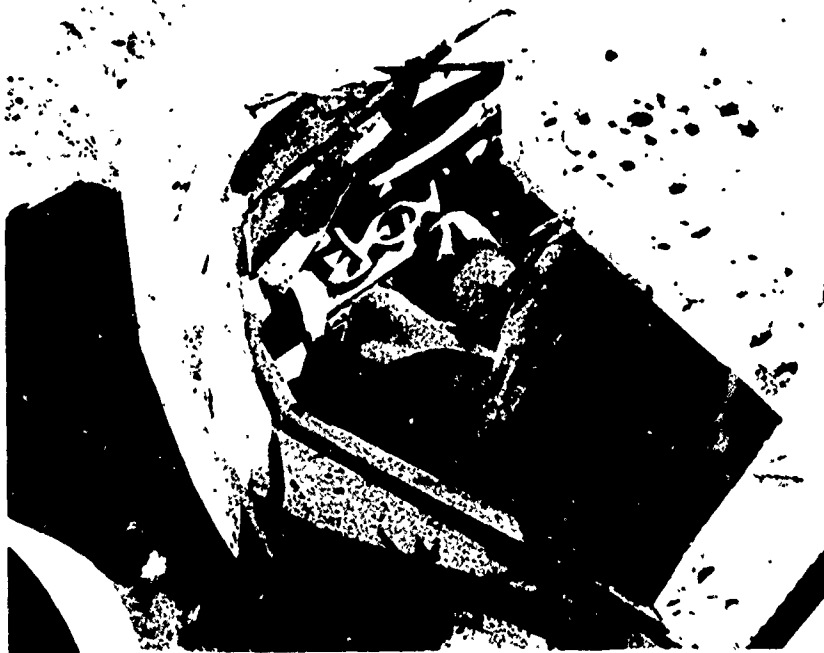
Figure 2-25 View of Cockpit Area of T-16 Vehicle, Showing Buckling of Side Structure Caused by Aft Forces on Forward Cockpit Bulkhead.

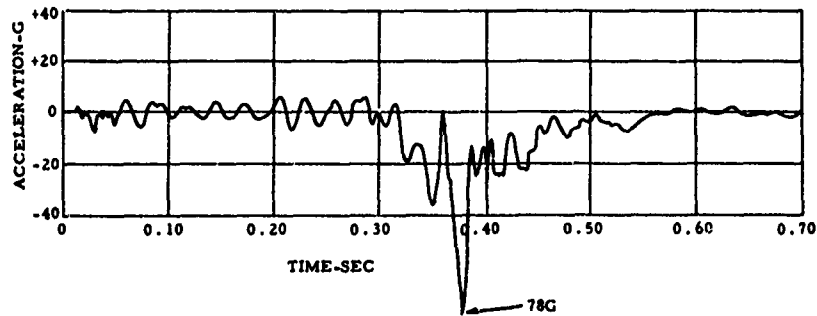
Figure 2-27. T-16 Cockpit Acceleration, Longitudinal.

Figures 2-27 and 2-34 show acceleration measurements recorded during the test.

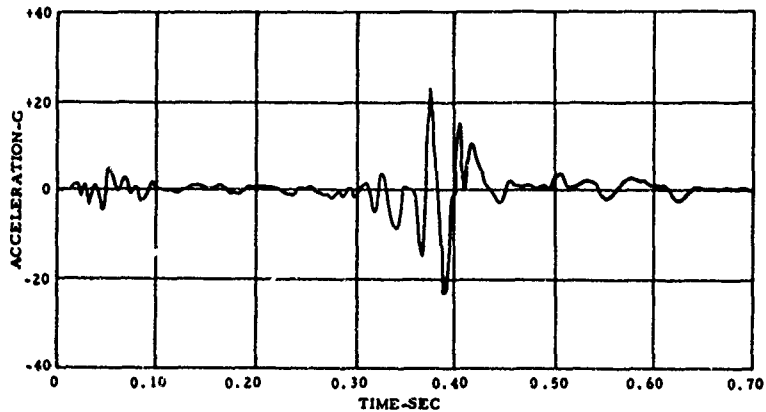
Figure 2-29. T-16 Cockpit Acceleration, Lateral.

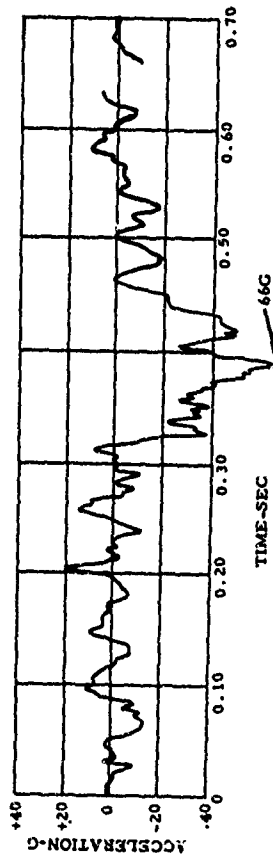
Figure 2-30 T-16 Mid-Cabin (c.g.) Acceleration, Longitudinal.

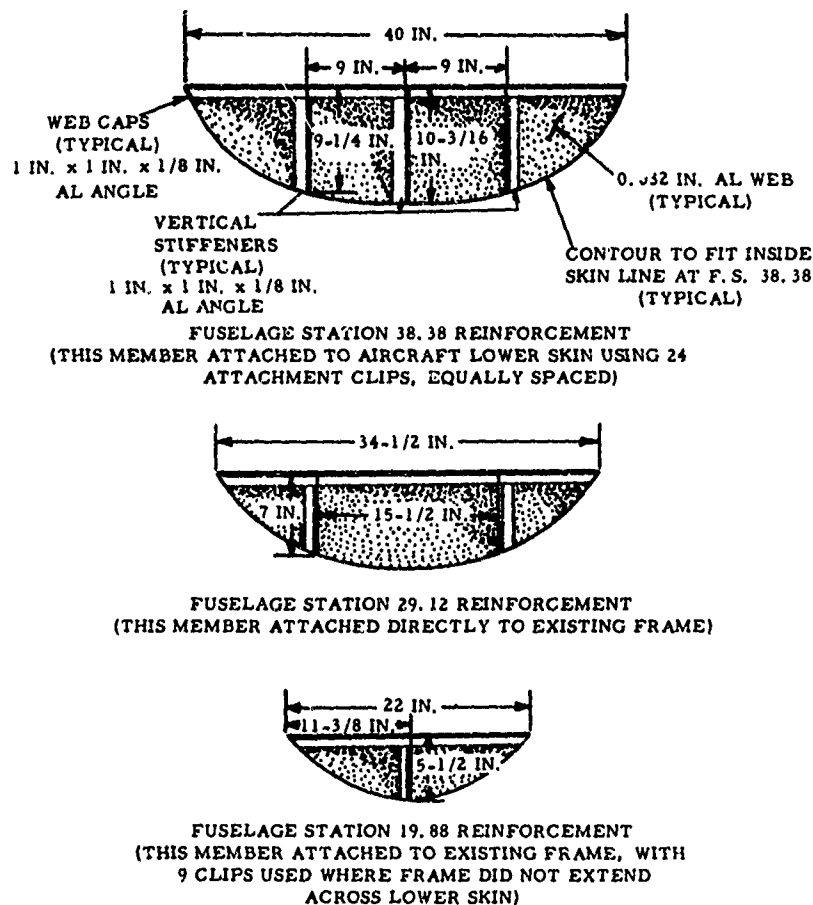
Figure 2-37. Sketches of Nose Structure Reinforcement Webs and Stiffeners.

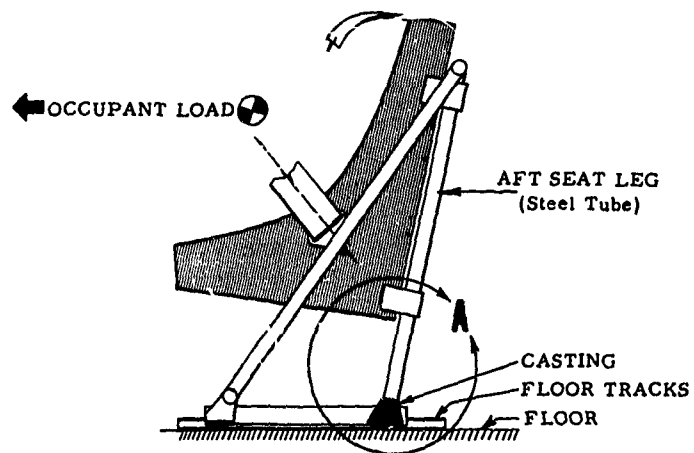
Aft Seat Lcg Casting Attachment.

The effect of not providing for relative seat leg-to-floor rotation is illustrated by Reference (2). The rear legs of a crew seat were attached to a base frame with castings as shown in Figure 3-2. The casting failed repeatedly in actual accidents as a result of combined axial and bending stresses acting at the region of stress concentration. With the slight modification to a pinned joint, the longitudinal load capacity was nearly doubled. It should be noted that the seat carried the seat belt and shoulder harness loads which is why the modified seat worked.

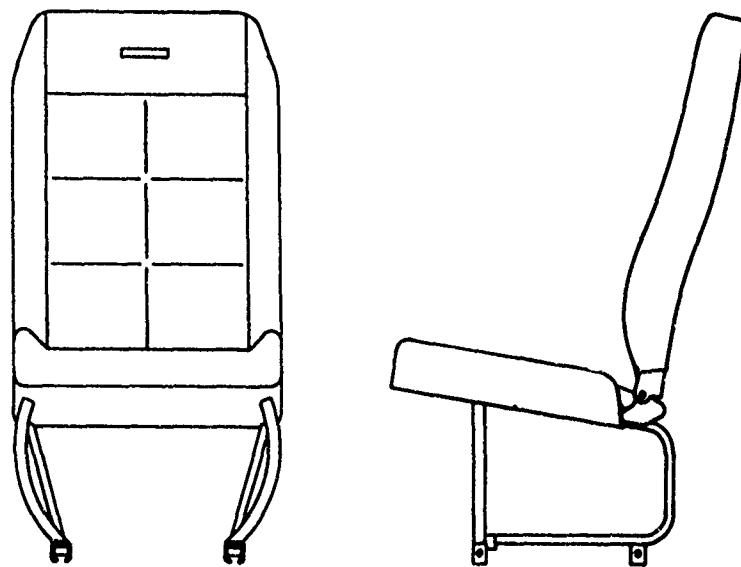
Fig. 3 - First seat design

The first geometrical configuration tried was a circular arc of large radius (Figure 3). In this configuration, failure would first occur in the center of the arc, where the distance is greatest from the line of applied load, but the bending would be spread over a length of the tube; as bending continued, the upper and lower sections would tend to pick up part of the load. The first development seat bottom was built of 0.5 x 0.035 in wall tubing for the basic frame, with the same size tubing for the front legs. This frame was designed to fit an existing production seat back assembly.

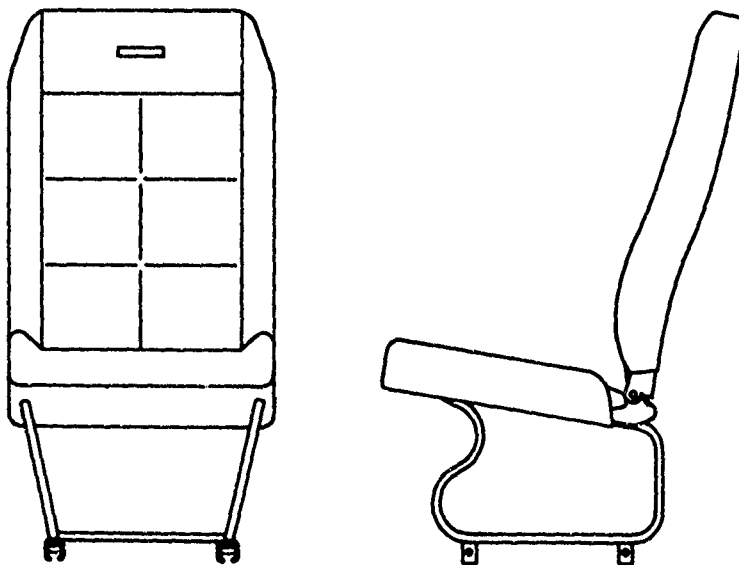
Fig. 4 - Second seat design

The next configuration chosen for the front legs was a double arc (Figure 4). By going to two bows, we reasoned, the load in each bow would increase because the center of each bow is further from the

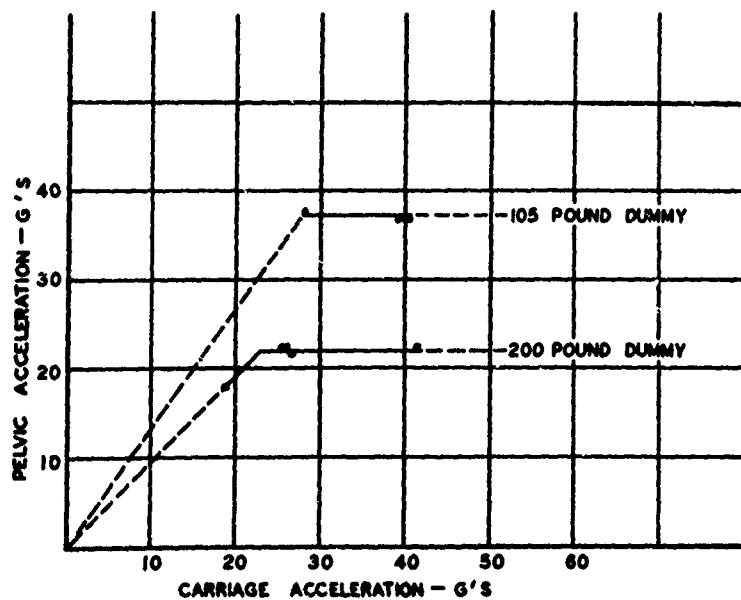
Fig. 5 - Maximum pelvic accelerations versus carriage accelerations

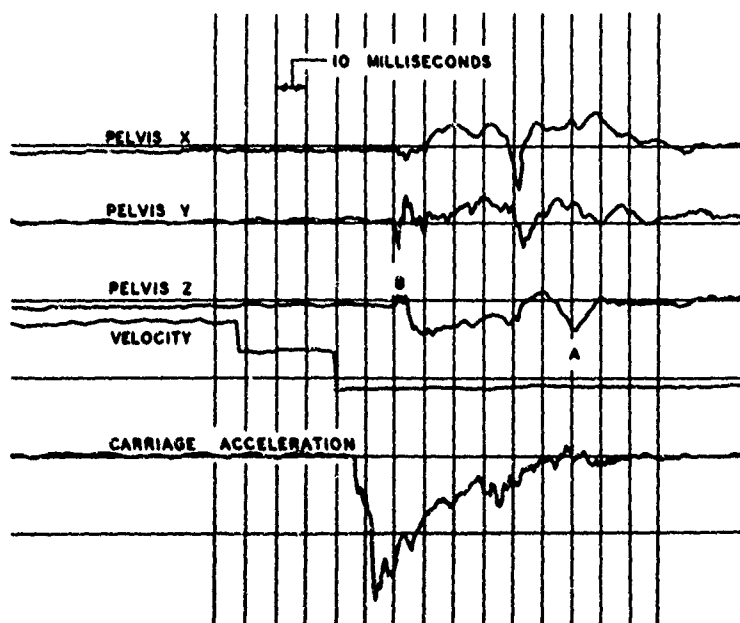
Fig. 6 - Oscillograph trace of dynamic test 1

The most severe test from the standpoint of the seat was Test 1. On this test, the impact velocity was 1840 ft/min (9.35 m/s) with a stopping distance of approximately 8 in (20.3 cm). The input deceleration was a roughly triangular pulse with a peak of 41.3 g, and the pelvic acceleration measured was nearly trapezoidal, with an average peak of about 20 g for a duration of 35 ms (Figure 6). The short 25 g pulse (A) occurring after the main pulse is due to the seat bottoming out, which would not have occurred at lower impact velocity.
